Manhole Inspection Summary

Manhole # S31MM_052MH

Record Plat: **31MM** Node: **052** Status: **New Manhole (Not in GIS)** Insp Date: **7/2/07 12:00 AM**

Location Address: **2201 FALLS RD**

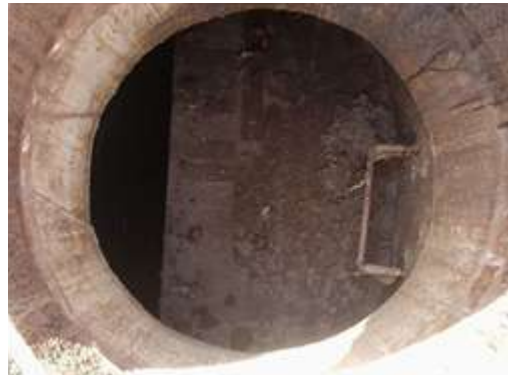
Top View

Evidence of surcharge - Bench debris.

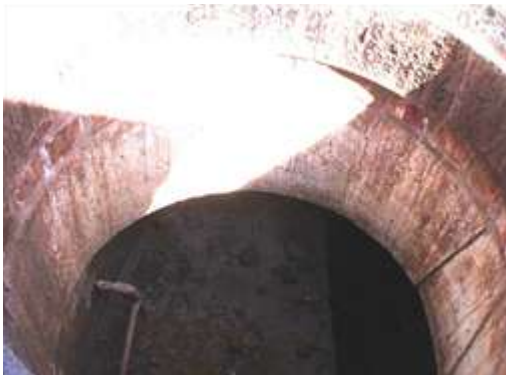
Defect

Frame leaks. Adjustment infiltration - other side.

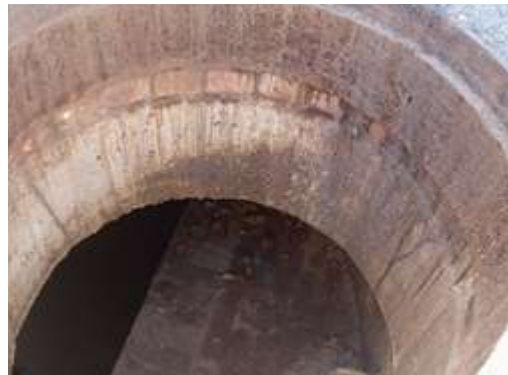
Defect

Frame leaks. Adjustment root intrusion and infiltration.

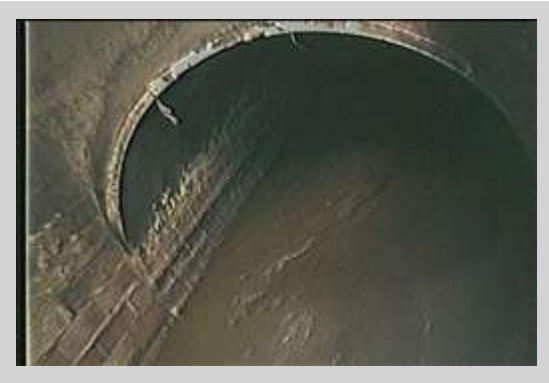
42 in. Circular Gravity Sewer Pipe Out @ 12 O'Clock

Infiltration: **Evidence** Pipe Seal Cond: **Unknown**

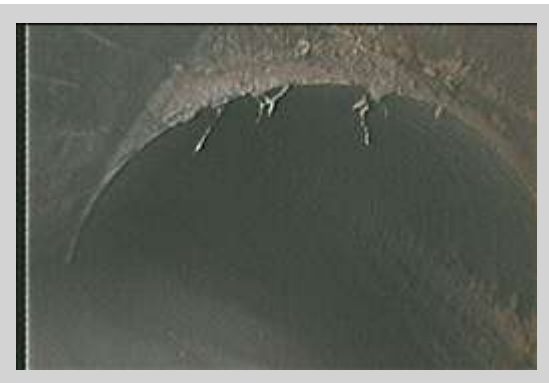
42 in. Circular Gravity Sewer Pipe In @ 6 O'Clock

Infiltration: **Evidence** Pipe Seal Cond: **Cracked**
